Service Bulletin

Starair Aircraft Co., Ltd.

Document No.: 2023-SA60L-27-01

Subject	Inspection and replacement of flap motor
Category	Important
Applicability	This bulletin applies to the Aurora SA60L light sport aircraft listed in Attached Table 1.
Finish Time	Aircraft within the scope of application must be done the inspection work in Article (1) of the Required Action(s) completely before the next flight. Aircraft within the scope of application must be done the work required by this service bulletin completely before December 20, 2023.
Reason	<p>According to the flap motor supplier, Some flap motors(Part Number : SP12C17A08-06-CAA) used in some Aurora SA60L aircraft (see Attached Table 1 for details) , may experience abnormal slipping of potentiometer components under certain usage conditions due to inadequate installation of related components during product assembly. Through internal analysis by our company, this situation may lead to a larger angle when the flaps are extended, leading to potential unsafe conditions.</p> <p>To avoid uncontrollable risks, the aircraft operator is required to inspect the aircraft within the scope of application as required and pay attention to

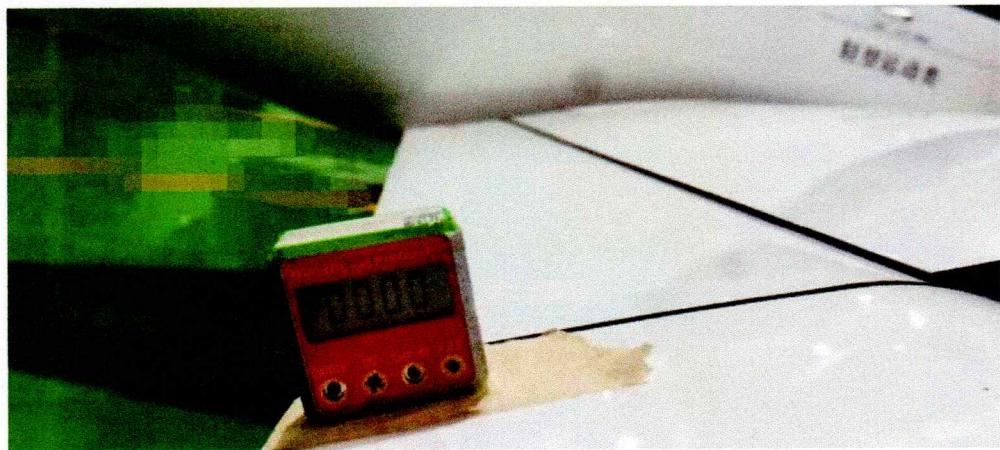
1.1.3 If they are not parallel, place the inclinometer on the aileron surface and set the reading of inclinometer to 0° with the aileron aligned with the rear surface of the wing tip, as shown in the following figure;

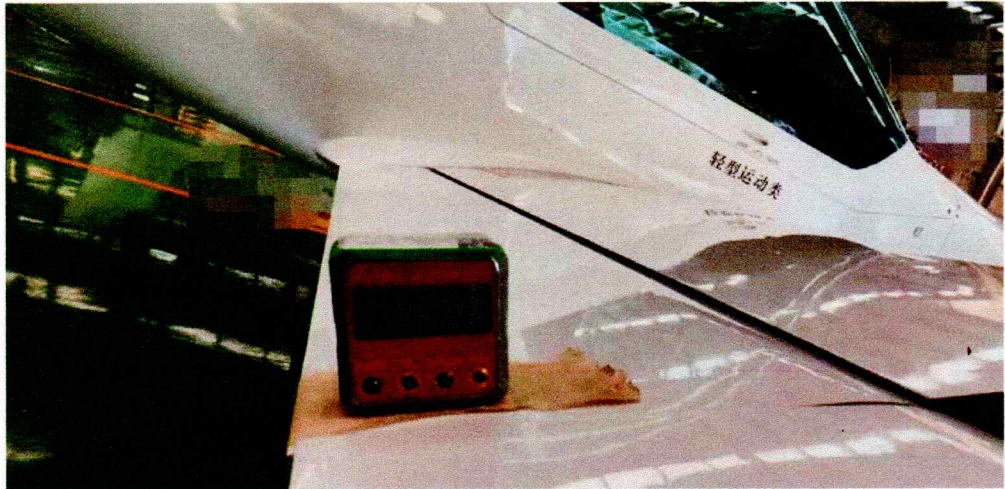
1.1.4 Move the inclinometer to the flap surface and check the reading of inclinometer , as shown in the following figure;

1.1.5 If the reading of inclinometer is less than 1.5° , the flap position is qualified, otherwise it is not qualified.

1.2 If the reading of inclinometer exceeds 1.5° , it is necessary to recalibrate the four flap positions according to the following steps, and verify them the four flap position before flying.
